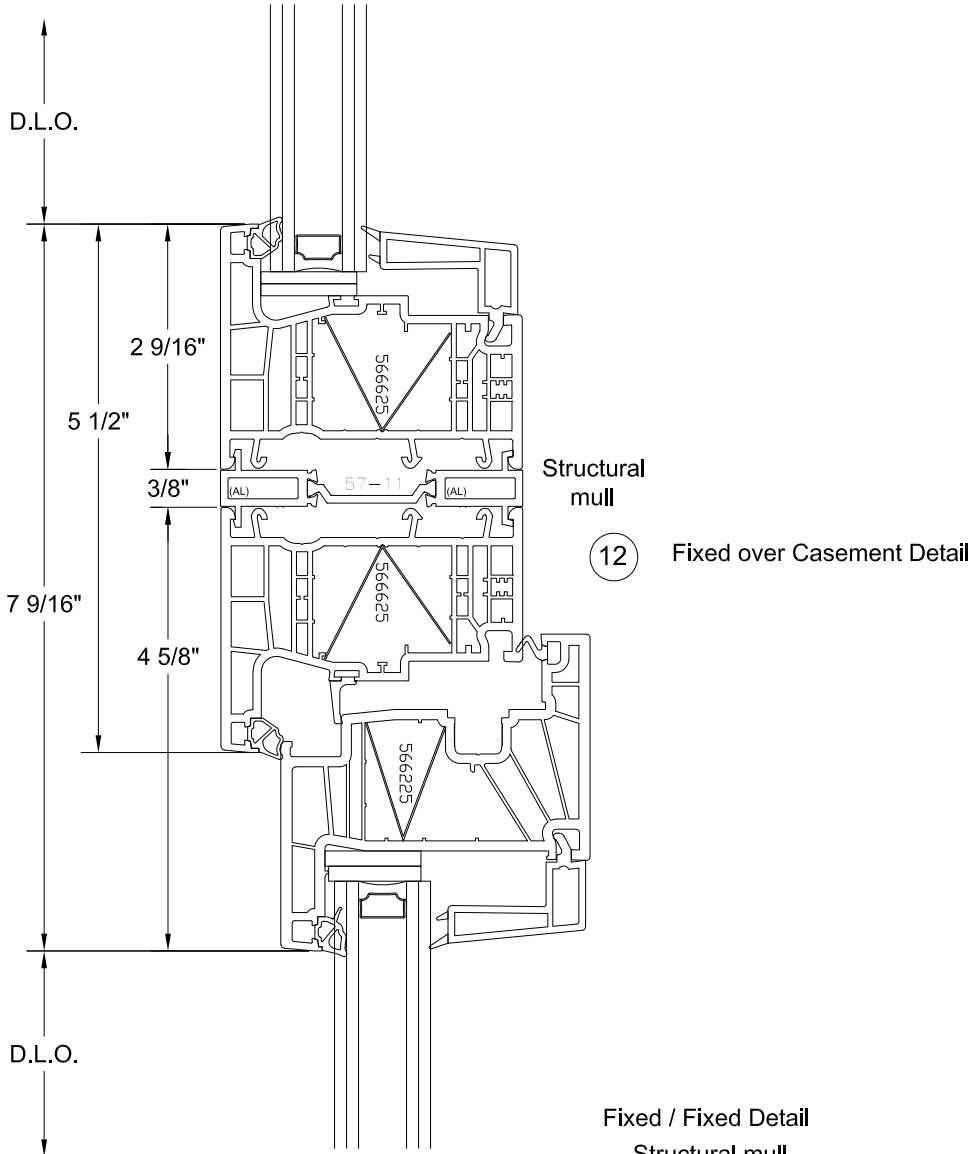
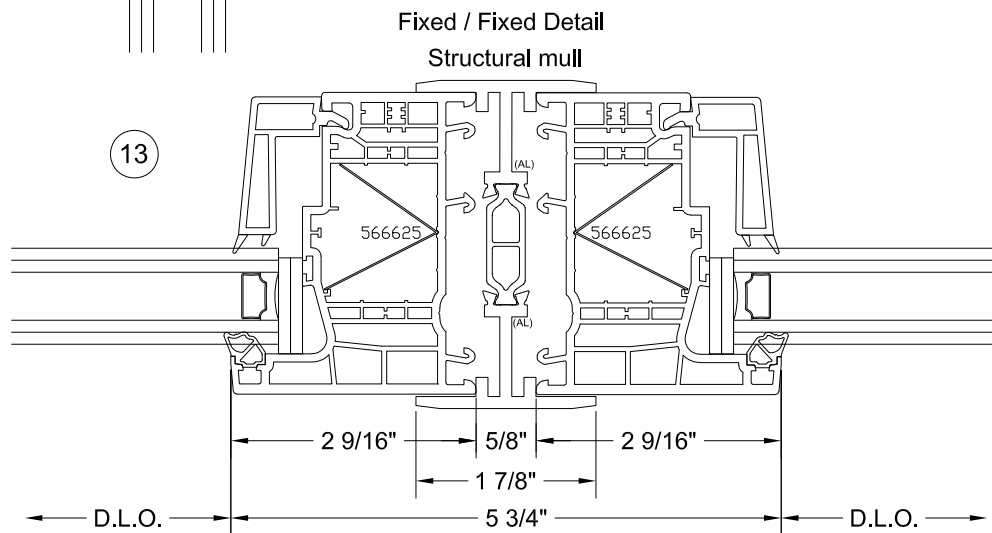
14

Structural Mull

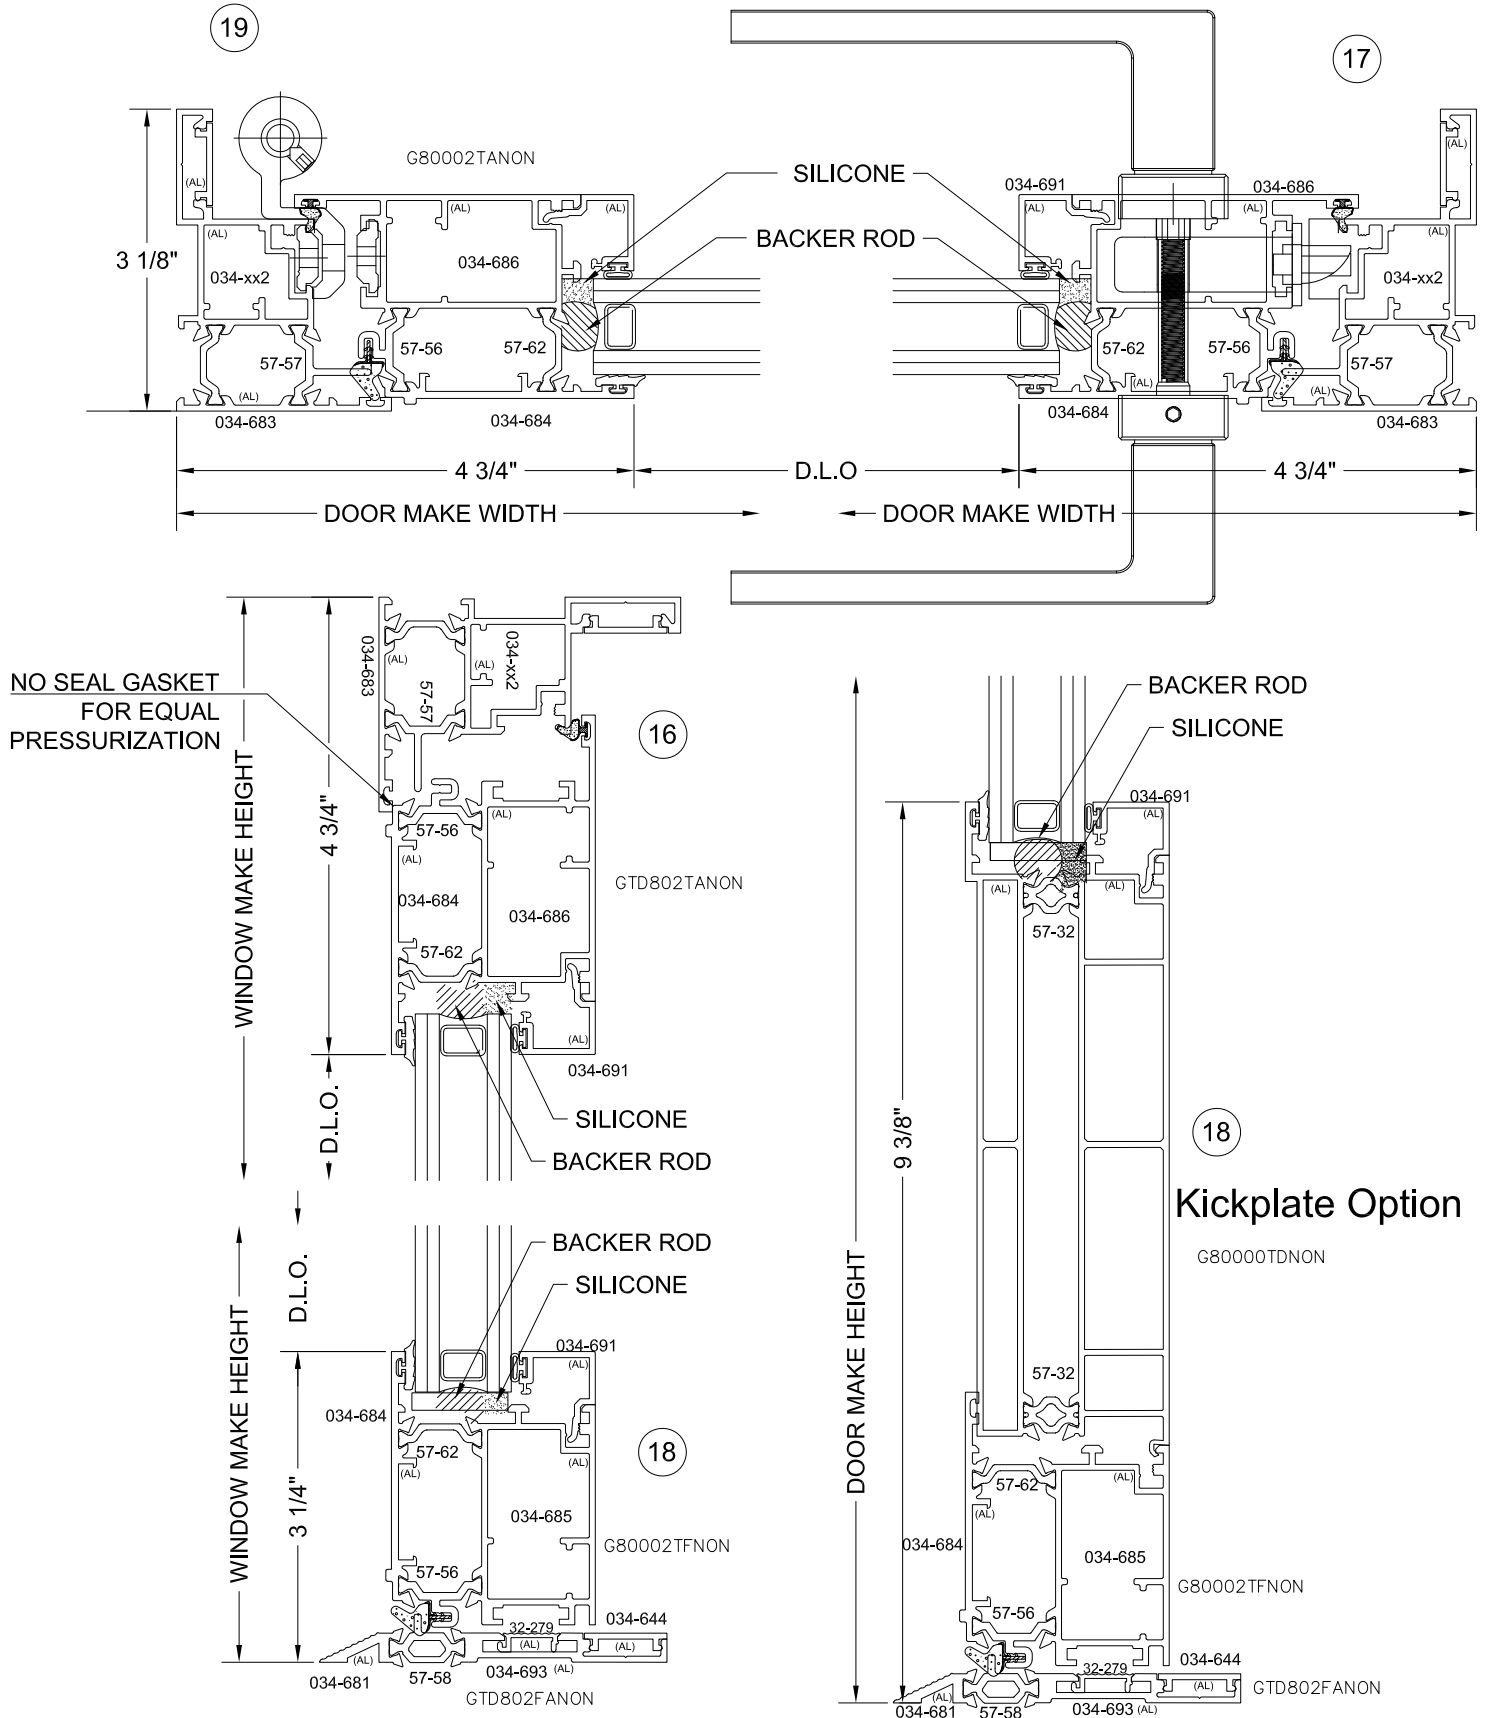
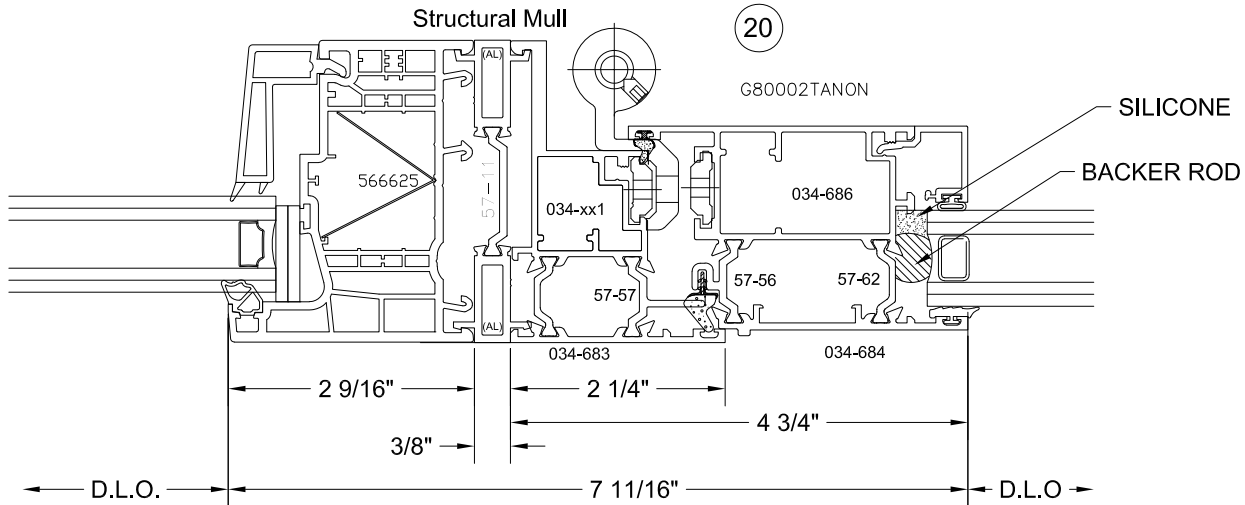
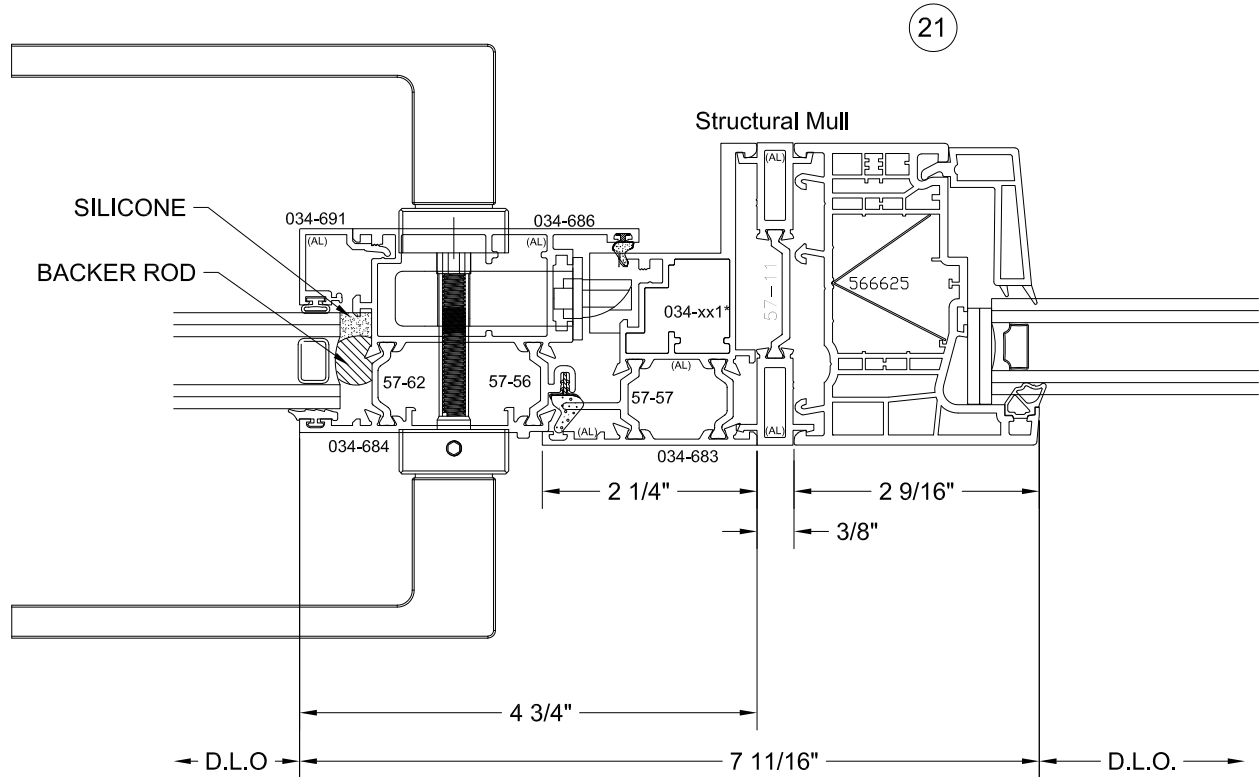
15

Structural Mull

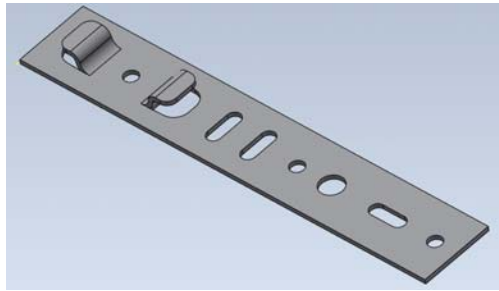
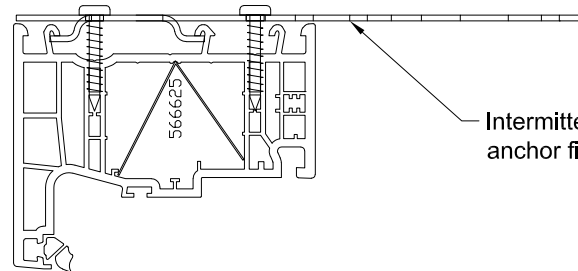
## STRAP ANCHOR

Intermittent strap  
anchor field install

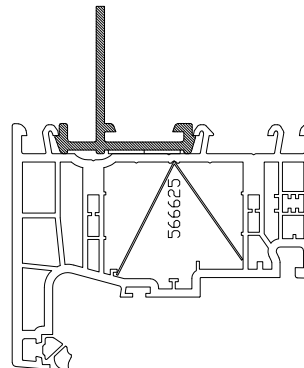
## NAIL FIN

Gap in nail fin that  
must be field sealed  
after field mulling top  
and bottom
